SERVICE BULLETIN

KAIR11001 – Front Chassis Tanarg

LANAS 28 March 2011

SUBJECT : Cracks in front chassis (ref : E305910) Tanarg.

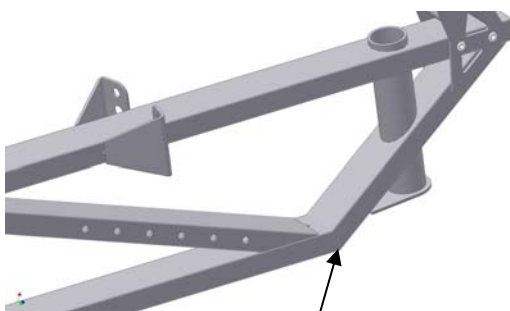
In a unique case, on a Tanarg trike, a crack on the 40x20 tube behind the lower level of the axis of the fork, at the point of soldering.

Zone à
inspecter

- As a precaution, we ask that before next flight, this zone should be carefully inspected.
- The checking of this particular point should be included in pre-flight checks;
- In case of cracking, stop flights and contact the factory for replacement of the front chassis.

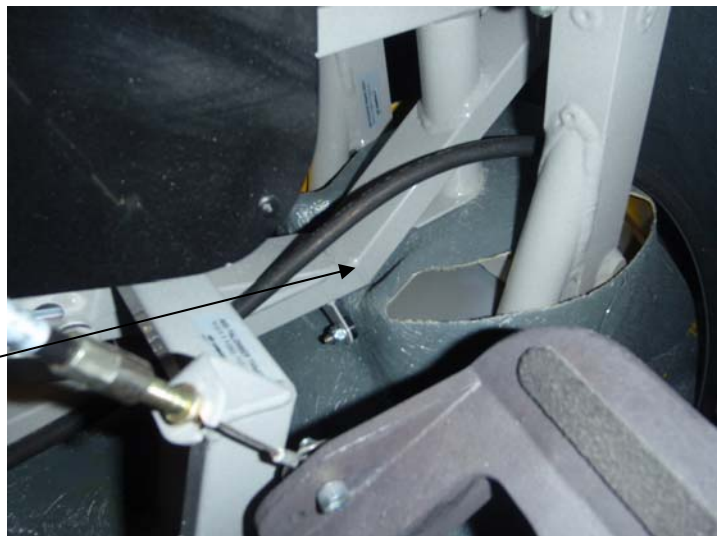
Zone à inspecter : entre le palonnier et le palier inférieur de la fourche.
