## ***SERVICE BULLETIN***

### **KAIR10002 – BioniX Fairings**

**LANAS 6 April 2010**

**SUBJECT** : Fastening of the fairings on the kingpost and A-frame struts of the BioniX.

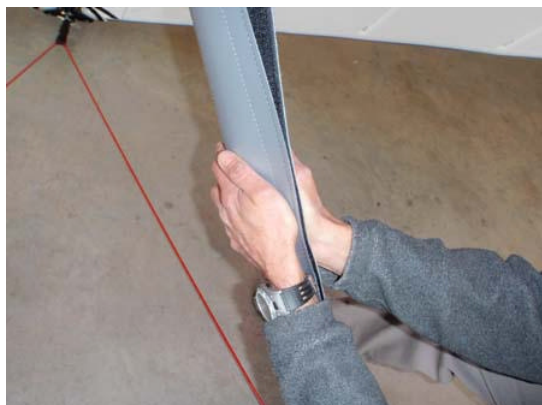
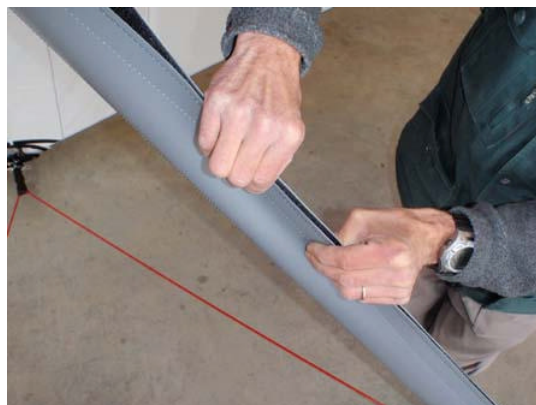
Possible opening of the trailing edge of the PVC fairings of the kingpost and A-frame struts at speeds approaching the VNE in case of insufficient closure of the Velcro strips, leading to the occurrence of very strong vibrations of the A-frame and structure of the wing.

Insufficient pressure applied on the trailing edge of the fairings during assembly reducing the contact surface of the Velcro strips.

Firmly press the trailing edge of the fairings all along with the palm of two hands during assembly. Repeat the operation while pinching the trailing edge with the fingers. Before each flight check that the Velcro strips are completely fastened.

In case of the occurrence of the vibrations problem during flight, reduce speed immediately, return to low-speed configuration, land in order to correctly reinstall the fairings.
