## SERVICE BULLETIN

### KAIR 17001 – GTE 582

**Subject:** Cracks on exhaust system on GTE 582 trikes

**Models concerned:** All GTE models equipped with the Rotax 582 engine

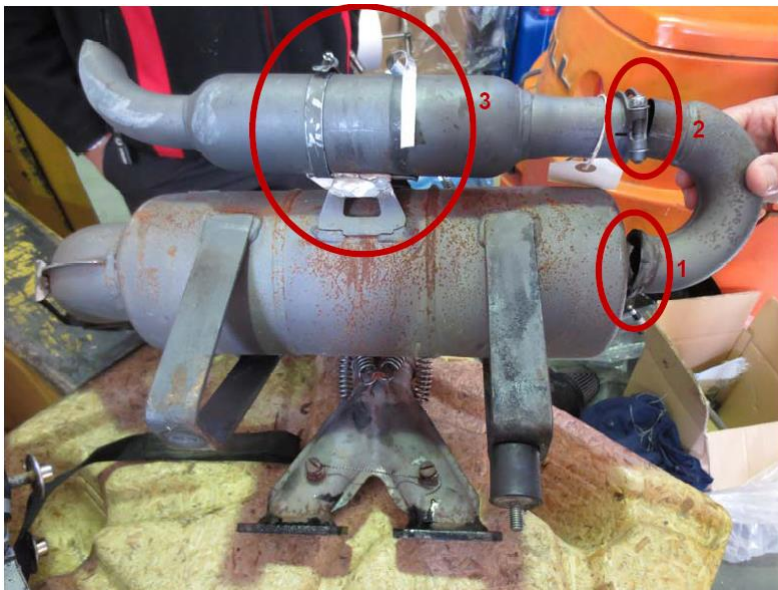
Possible occurrence of cracks on the after-muffler assembly (see picture).

An accident occurred on a GTE trike equipped with a Rotax 582 engine in Spain. Different cracks have led to a separation between the muffler and the after-muffler. This part therefore separated from the engine and got through the propeller, resulting in catastrophic damages to the blades.

The damages on the after-muffler are the consequence of vibrations and heat stress. These factors are the normal aging factors of any exhaust system.

1 : Possible cracks on the weldings between the elbow and the muffler

2 : Clamp holding the after-muffler on the elbow

3 : Possible cracks on the weldings of the butterfly shape part holding the after-muffler on the muffler

- check exhaust system prior to any flight.
- perform careful periodic checks as indicated in the manuals (Air Creation GTE503/582 instruction and maintenance manual, and Rotax.582 maintenance manual).

In case cracks are detected, stop flying and contact immediately our aftersales service to have the part repaired or replaced.
